**BRISTOL MILLS DAM**  
**INSPECTION / EVALUATION REPORT**

**DAM NAME:** Bristol Mills Dam  
**STATE DAM ID#:** 06063  
**NID ID#:** ME00280  
**MEMA ID#:** 077  
**OWNER:** Town of Bristol  
**TOWN:** Bristol, Maine  
**CONSULTANT:** Wright-Pierce  
**DATE OF INSPECTION:** September 24, 2015

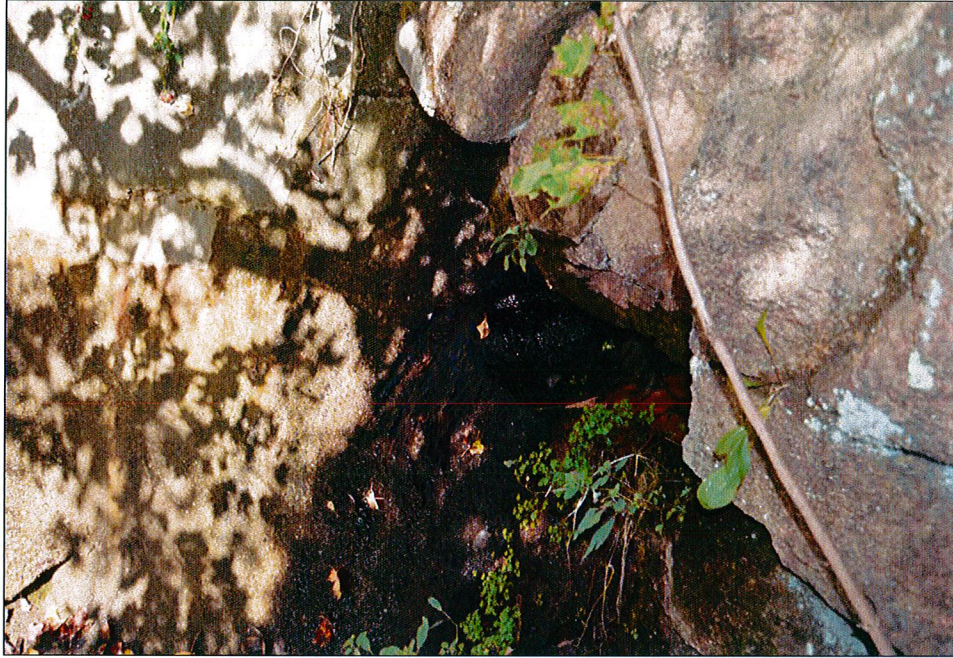
**Photo #15 – Voids at Abutment near Penstock Ledge Interface**

- Repair spalled concrete and fill cracks along the upstream face at the sluiceway walls and the former intake structure.
- Repair voids at the toe of the dam.
- Repair cracks on the downstream face at the former penstock outlet and along the rock interface with the dam
- Perform the additional studies noted in Section 3.2.

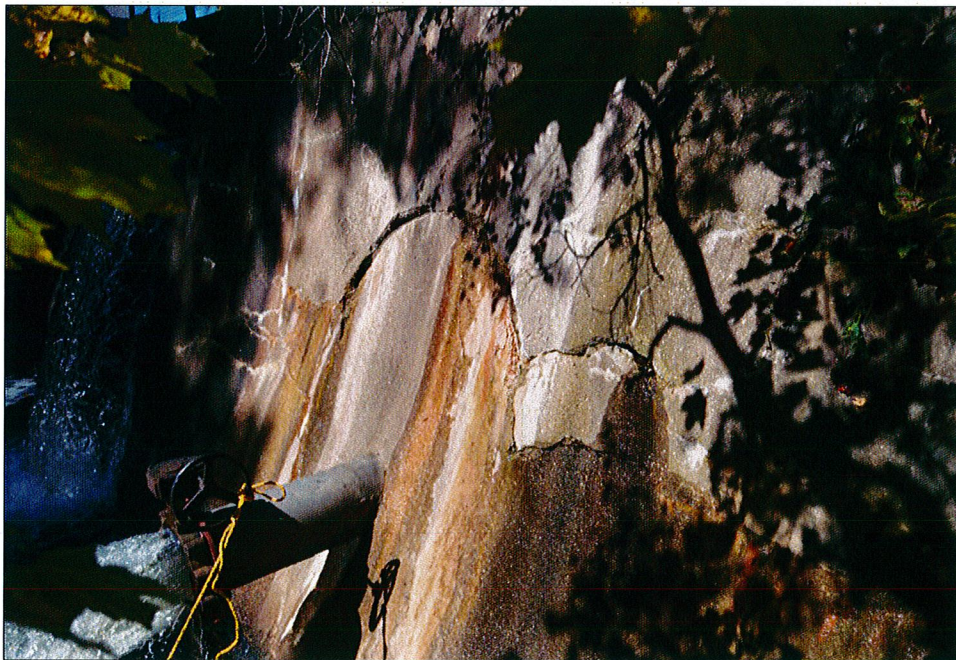
**Photo # 16 – Cracks in Downstream Face Right Side**

1. Repair the cracking on the downstream face by grouting the cracks
2. Fill the voids along the toe of the dam
3. Repair the spalled concrete areas along the upstream intake and sluiceway areas.
4. Prepare an Emergency Action Plan for the Dam
5. Prepare a structural stability analysis of the dam
6. Perform an Inflow Design Flood Study (IDF) to determine the appropriate design IDF and further evaluate the dam's spillway capacity to determine stability during the IDF event.

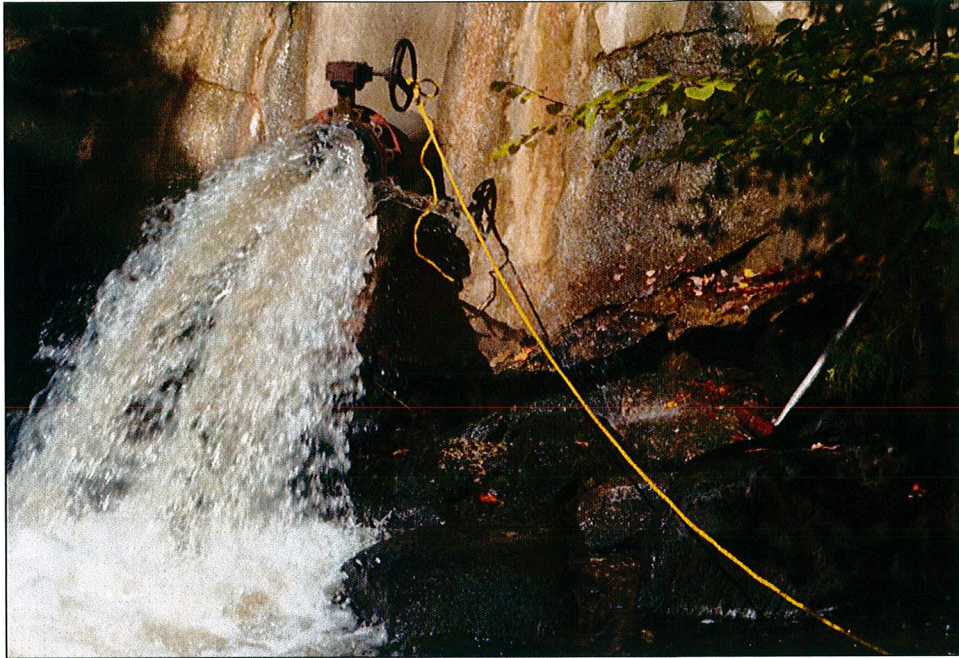
**Photo # 17 – Voids at base of Downstream Abutment**

(1) Undercutting the outlet?	X			Voids observed at toe of downstream face left side
(2) Eroding the embankment?		X		
<b>8. Emergency Spillway</b>				
a. Does Concrete spillway show:

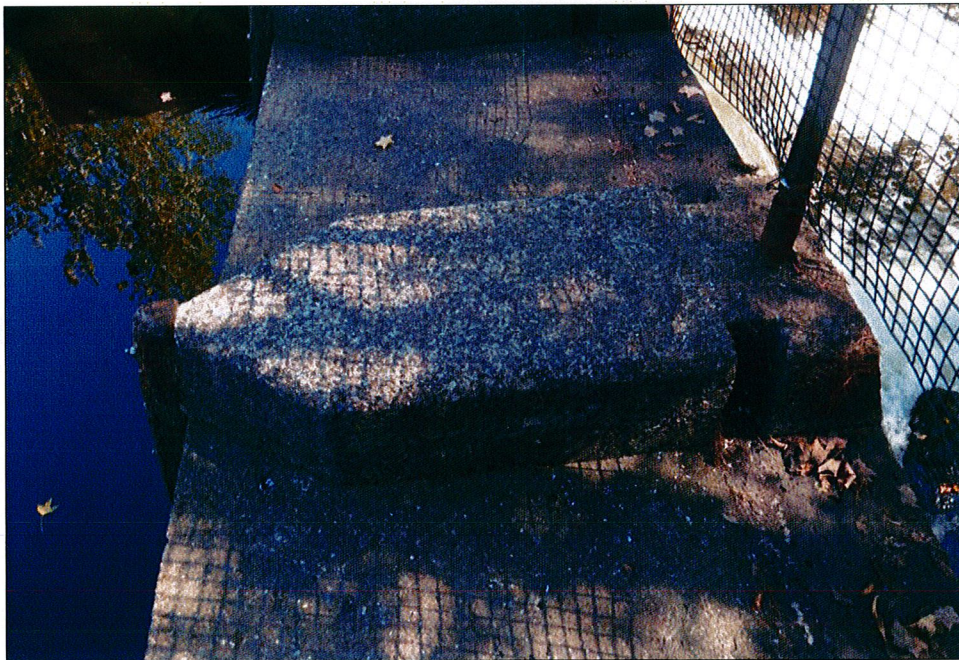
**Photo 18 – Minor Concrete Erosion At Spillway Crest**

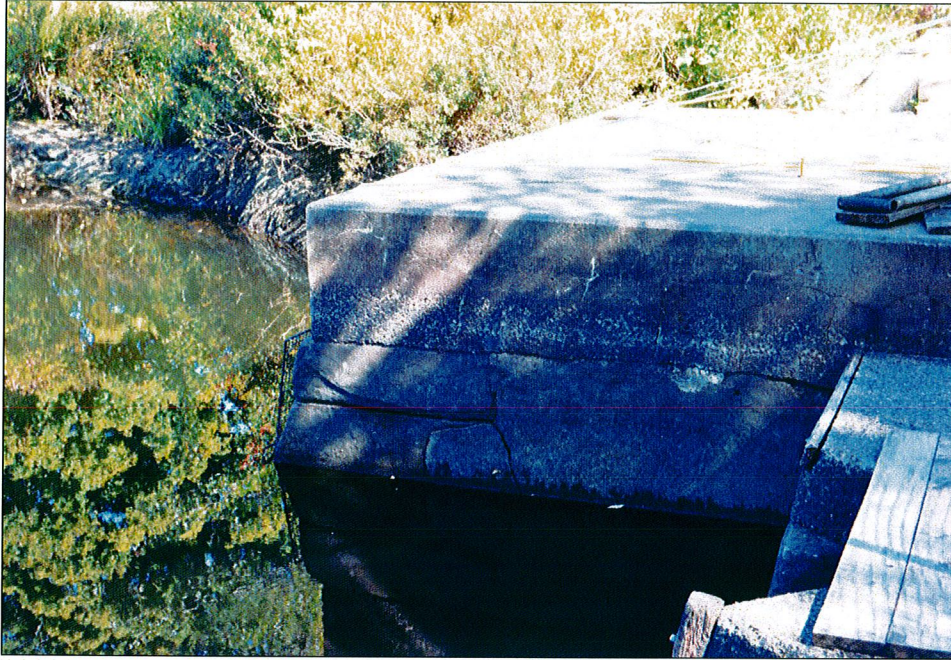
**Photo #19 – Penstock Intake with Loss of Concrete**

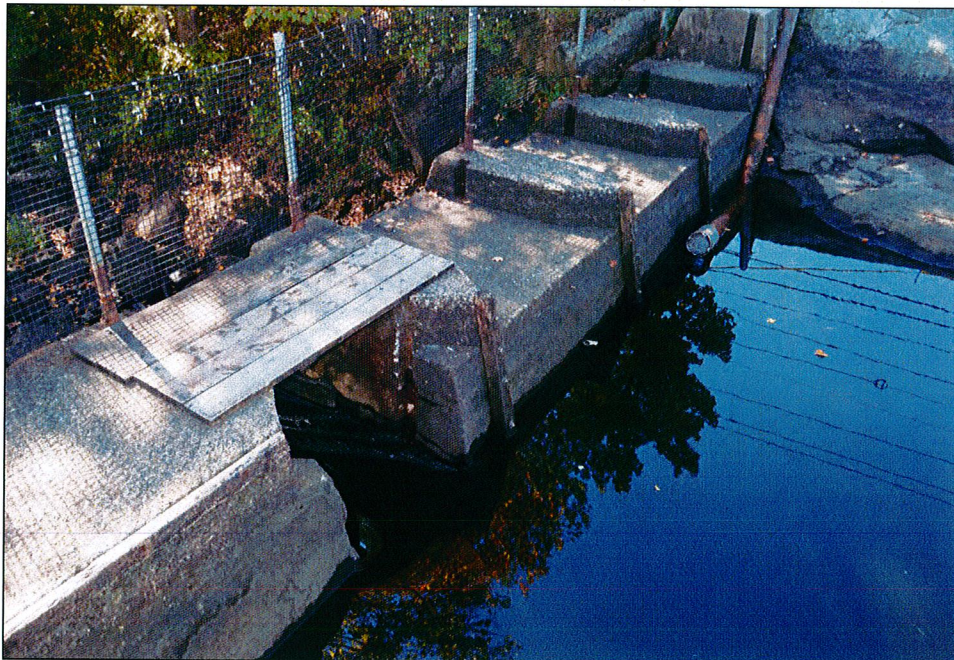
**Photo #20 – Sluiceway with Concrete Cracking and Exposed Rocks**

b. Do concrete surfaces show:				
(1) Spalling?	X			Inside of sluiceway wall
(2) Cracking?	X			inside sluiceway wall
(3) Erosion?		X		
(4) Scaling?		X		
(5) Exposed rebar?		X

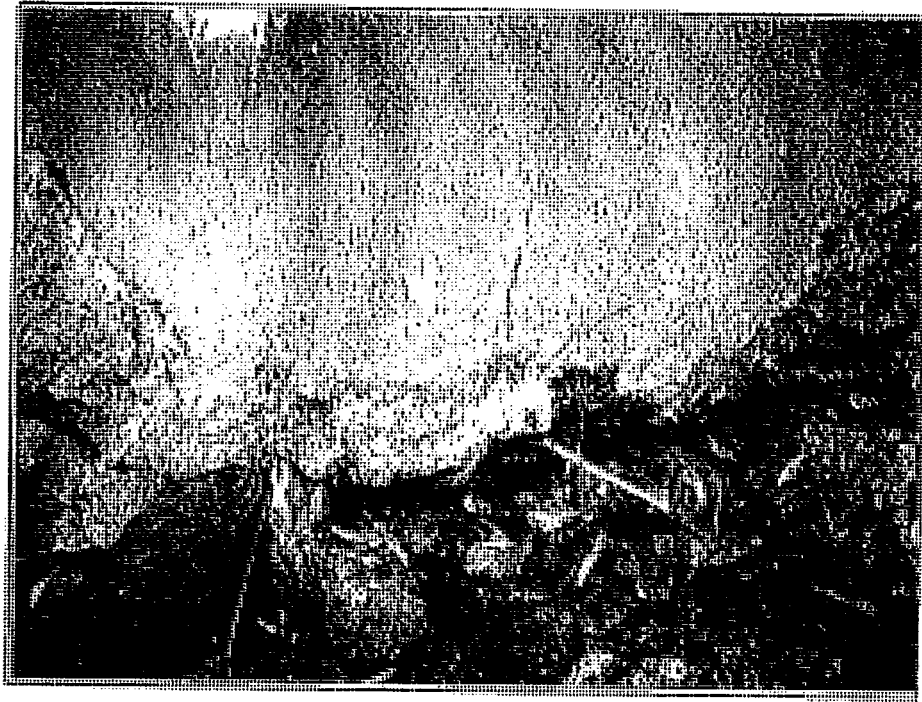
Photo B-3      Bristol Mills Dam.  
Old intake. Note deterioration of 1994 gunite and seepage at base.

1. Reduce seepage through the intake and rehabilitate the deteriorated base of the spillway and old intake structure.
2. Evaluate the effect of the reduced spillway hydraulic capacity on stability of the dam.
3. Provide access to the spillway and sluice stoplogs during flood conditions.
