Friendship Street School Fire Code Compliance Waldoboro, Maine

FINDINGS

NARRATIVE

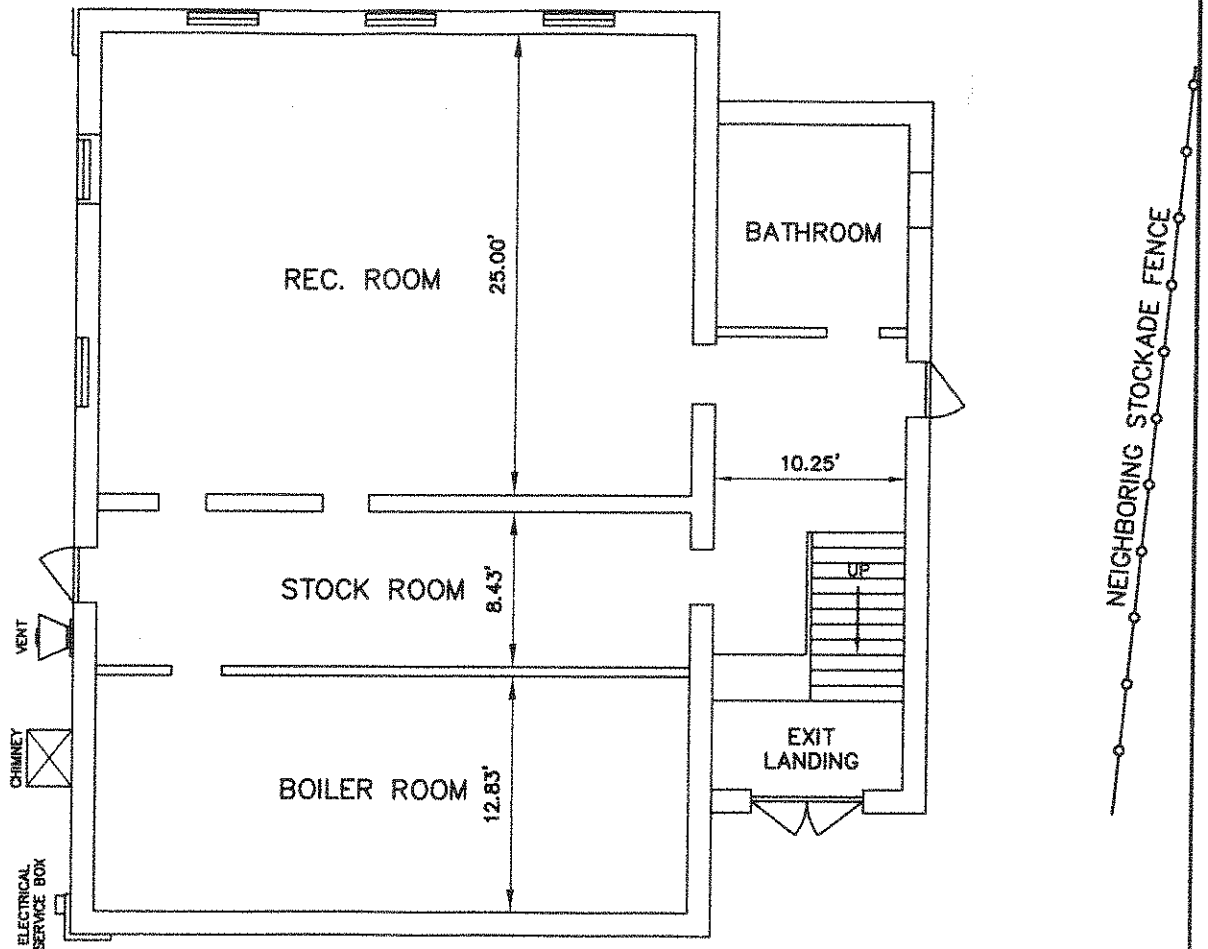
GROUND FLOOR LAYOUT PLAN

The ground floor has three exits: two exits to ground level (See Photographs 5 and 6) and stairs up to the front entrance. There are no recommendations for the ground floor because the location and number of exits (See Figure 1, Ground Floor Layout Plan) are adequate.

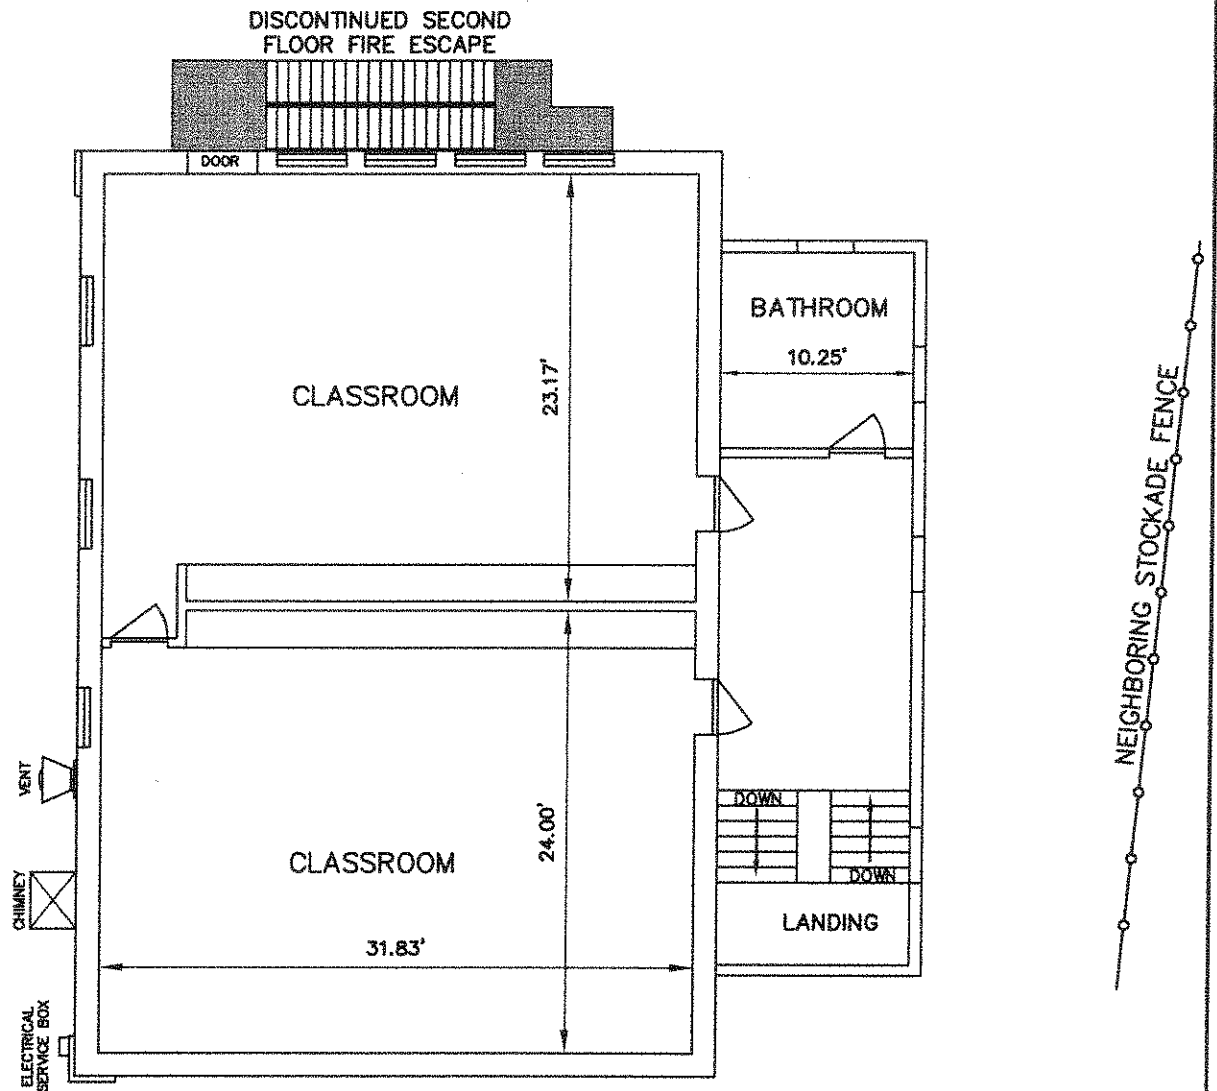
SECOND FLOOR LAYOUT PLAN

- The ground floor has three exits: two exits to ground level and stairs up to the front entrance (See Figure 1).
- The first floor has three exits: one to an ADA ramp, one exit down four steps to the front entrance and one approved existing fire escape (See Figure 2).
- The second floor has one stair exit to the first floor and one non-compliant fire escape (See Figure 3).

Because this fire escape is considered unsuitable for its intended purpose, another exit must replace it. The location of this fire escape can be seen in **Figure 3, The Second Floor Layout Plan**. The new exit must meet several code requirements, including exterior stair dimensions and protection from potential fire from nearby windows. If the Town intends to install a sprinkler system, the stairs do not need to be protected from fire from nearby windows.

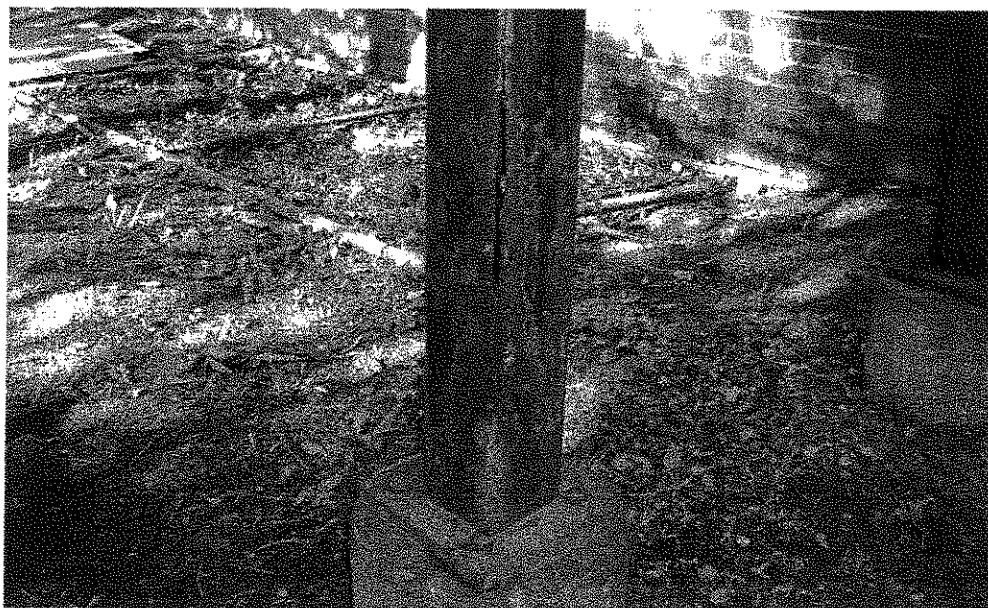
Photograph 1

Until recently, both fire escapes serving the first and second floor were considered approved existing fire escapes. Although they didn't meet all the codes in the NFPA Life Safety Code, they were considered compliant because they were "approved existing" by the State Fire Marshal's office. During a more recent visit by State Fire Marshal personnel and Pine Tree Engineering, one of the members supporting the second story fire escape appeared to be structurally compromised (**See Photograph 1**). As a result, the Fire Marshal's office has requested that the Town make the second floor available only for temporary storage until further action is taken.

The Fire Marshal's Office will allow the second floor to be reused when an adequate second exit is provided. They will allow the use before all the window protection provisions are in place as long as there is a definitive plan for window protection. Window protection could include adding a one-hour rating to the window openings or adding an approved automatic sprinkler system.

A new second exit could be installed in several locations. If the building has a sprinkler system, the second exit needs to be separated from the top of the stairs by **one third** of the total diagonal distance of the building (LSC 7.5.1.3.3). However, if the building is not sprinklered, the exit needs to be separated by **one half** the diagonal distance (LSC 7.5.1.3.2). The longest diagonal distance of the building is approximately 60 feet, so the exit needs to be 20 or 30 feet away from the top of the stairs, depending on the installation of an approved automatic sprinkler system.

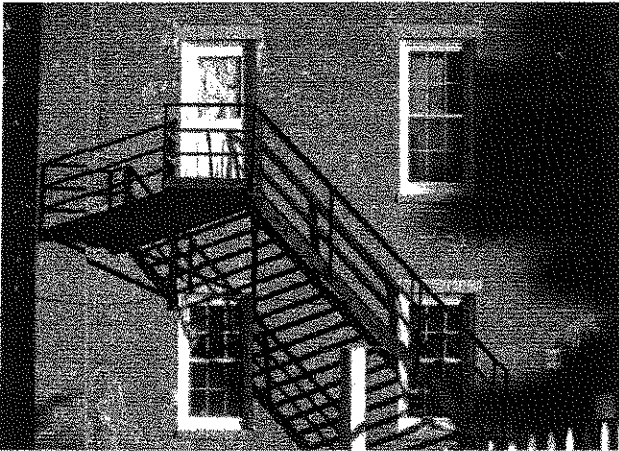
Photograph 3

Because the existing steel fire escape (**Photograph 3**) is considered an approved existing exit, the first floor does not need improvement for its Head Start occupancy.

Eventually this fire escape should be discontinued. If the corridor serving both classrooms was a compliant "exit access corridor", this fire escape would not have to be replaced by another exit. To make the corridor a compliant exit access corridor, it will need:

- to be cleaned of all obstructions
- to be separated from the classrooms by the proper fire rated components
- to provide two means of egress with proper arrangement (which means the proper distance from each other)

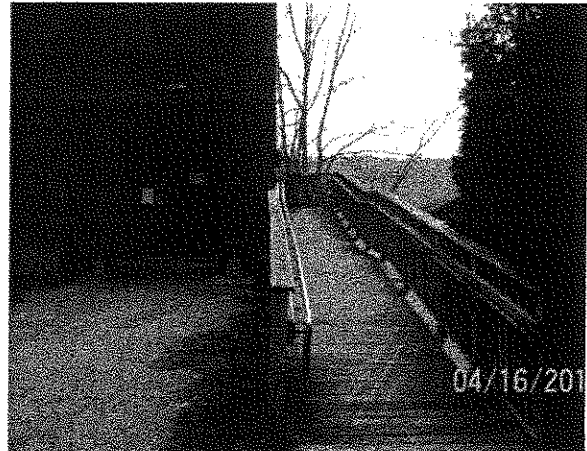
Photograph 4

The corridor has two exits (See **Photograph 4** and **Figure 2, First Floor Layout Plan**), the front entrance and the ADA ramp. The two exits need to be separated by one third the total diagonal distance of a sprinklered building or one half the total diagonal distance of a non-sprinklered building. Since the exits are 20 feet apart (See **Figure 7**) the space could be considered an exit access corridor if the building were sprinklered.

The corridor also needs to be separated from the classrooms and lavatory by 20-minute fire rated doors that will self close and latch. The existing doors may be used, but will need fire rated glass and self closing devices. Door levers may need to be upgraded so the doors latch properly. The door to the stairwell serving the second floor will need to be replaced by a 30-minute door that is self closing and latching (LSC 8.6.5(3), p.101-86).
