Friendship Street School Fire Code Compliance Waldoboro, Maine

FINDINGS

NARRATIVE

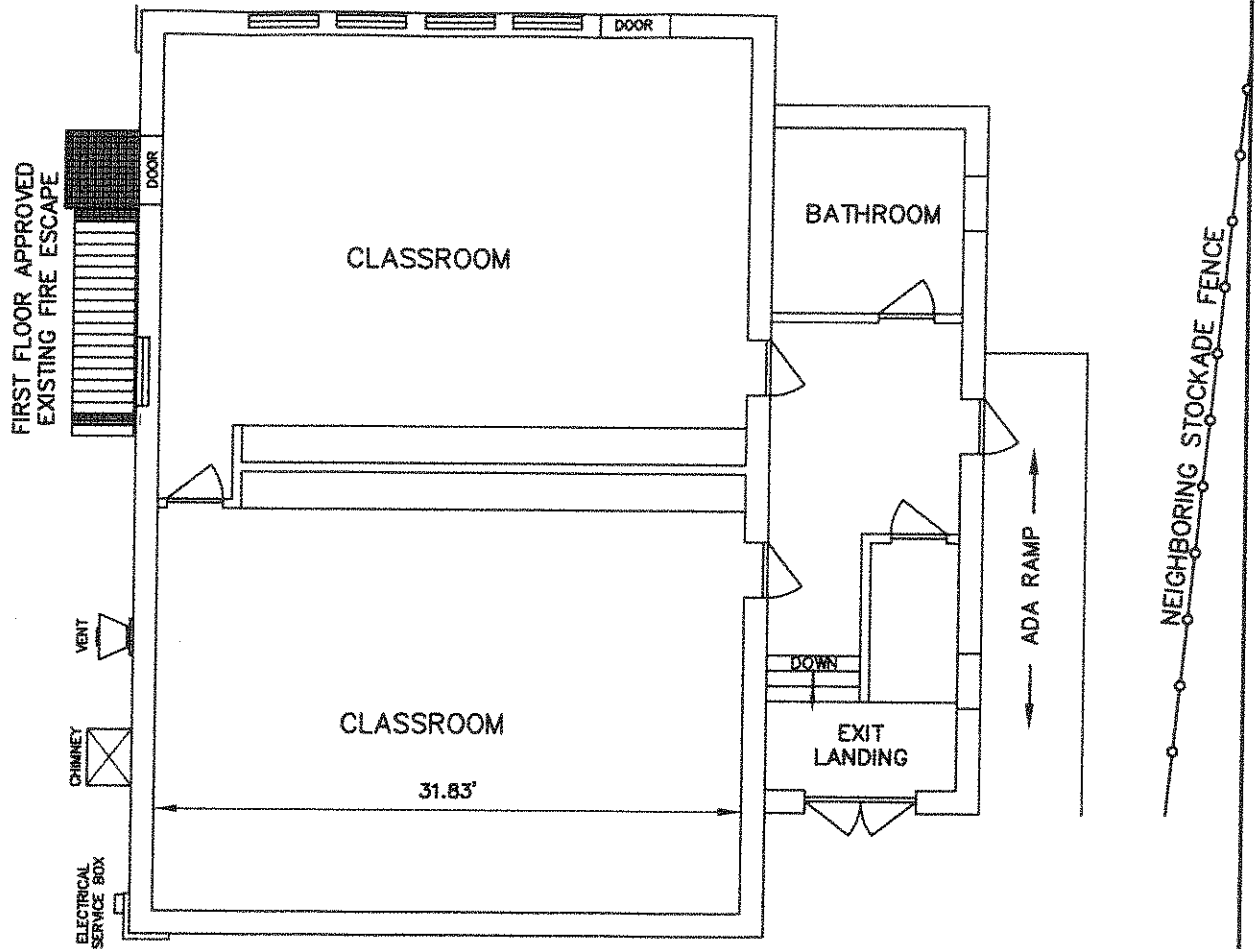
FIRST FLOOR LAYOUT PLAN

- The ground floor has three exits: two exits to ground level and stairs up to the front entrance (See Figure 1).
- The first floor has three exits: one to an ADA ramp, one exit down four steps to the front entrance and one approved existing fire escape (See Figure 2).
- The second floor has one stair exit to the first floor and one non-compliant fire escape (See Figure 3).
